Test Excavations at the Warner's Ranch Ranch House (Warner-Carrillo Ranch House)

Stephen R. Van Wormer and Susan D. Walter

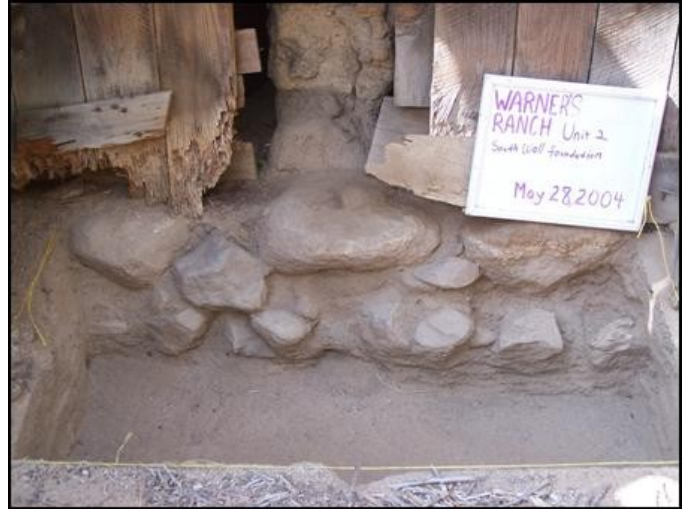
Figure 10.4. Cobble foundation and the end of the western interior dividing wall in Unit 2.
Courtesy Stephen R. Van Wormer and Susan D. Walter.

The condition of the foundation varied along its length. At the western most exposure in Unit 2, the foundation is intact and undisturbed (Figures 10.4 and 10.5). Moving east to the next exposure in Unit 10, the upper course of cobbles had been removed leaving the lower row intact (Figures 10.6 and 10.7). Continuing eastward to Unit 1, the foundation was highly disturbed in the west half of the unit, which is on the west side of the eastern most interior-dividing wall and under the center bedroom of the south wing. The upper courses appeared to be missing, and the smaller stones of the lower course were jumbled. Remains of a 4 by 4 inch wood post that had originally been placed against the foundation had been pushed aside to the south. In the east half of the unit under the interior dividing wall and the easternmost bedroom, the foundation was intact (Figures 10.8 and 10.9). In the eastern most excavation at Unit 3, the foundation was intact and undisturbed under the former east bedroom (Figures 10.10 and 10.11).

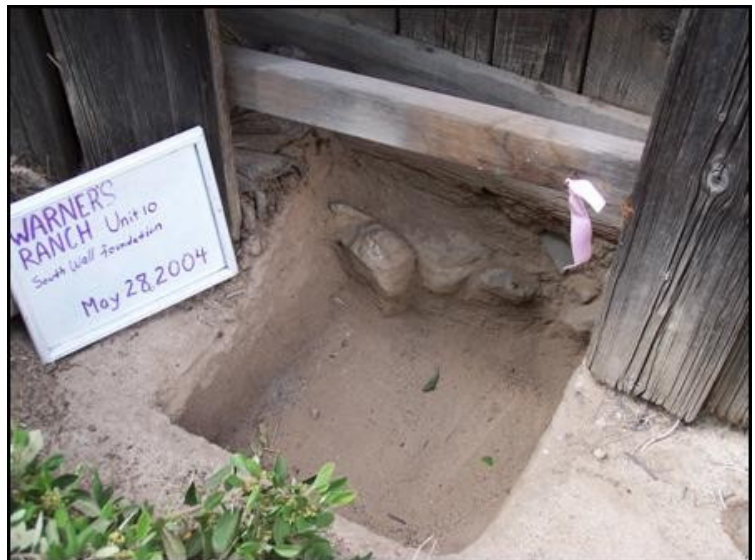
Figure 10.6. Disturbed foundation in Unit 10.
Courtesy Stephen R. Van Wormer and Susan D. Walter.

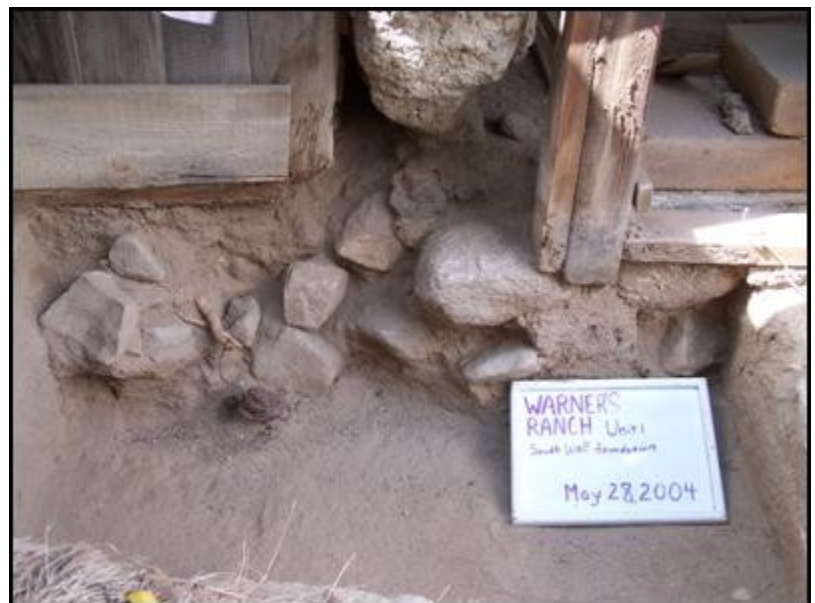
Figure 10.8. Cobble foundation in Unit 1. The west half is badly disturbed while the eastern portion remains intact. Courtesy Stephen R. Van Wormer and Susan D. Walter.

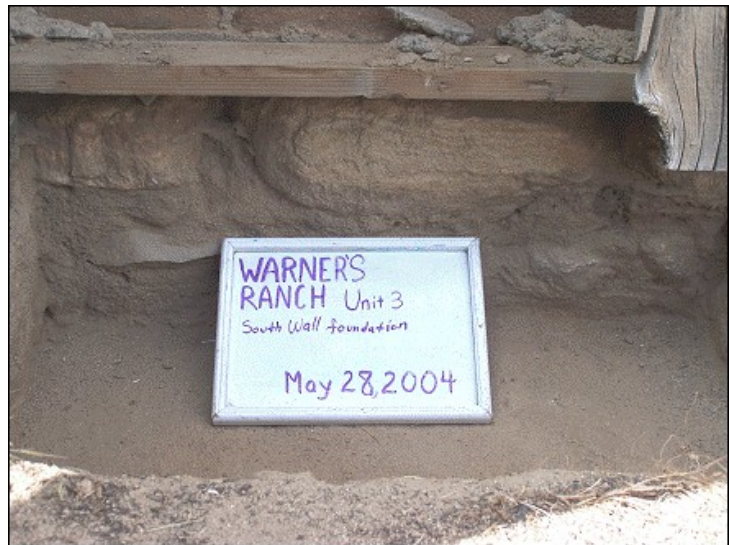
Figure 10.10. Intact foundation stones in Unit 3. Courtesy Stephen R. Van Wormer and Susan D. Walter.

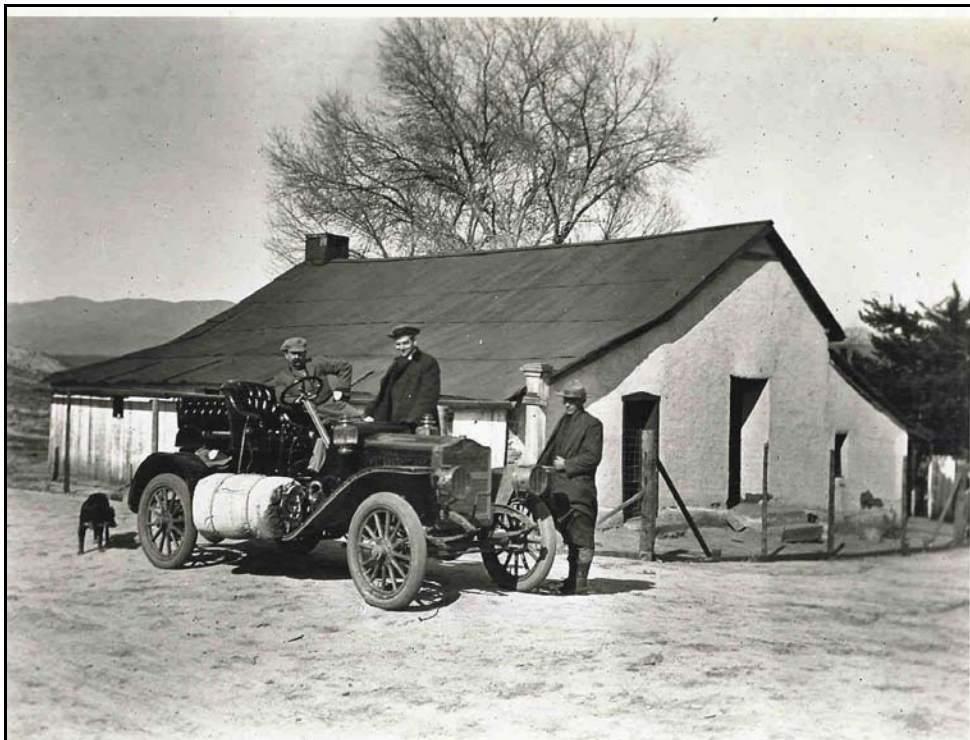
Figure 10.14. Photograph of the ranch house circa 1910. Note the board and batten siding along the south side and the masonry steps and facing along the base of the east wall. Courtesy Stephen R. Van Wormer and Susan D. Walter.

The original southern exterior adobe wall west of the southeast bedroom might have been taken out when Vail Ranch personnel reoccupied the building and converted it into a family home for its foremen in the late 1880s and early 1890s. This observation is based on structural evidence in the building and documentary evidence from historic plat maps. The interior board siding of the existing southern exterior wall exhibits machine-cut square nails. Newspaper under the wallpaper on this wall in the west bedroom has masthead dates of 1874. The framing and exterior board and batten siding of the southern exterior wall was constructed with round wire nails indicating a construction date later than the board siding on the interior of the wall. Based on the square nails and newspaper dates, it would appear that the interior siding was attached to the original adobe exterior south wall sometime after 1874, during the later part of the Carrillo occupancy of the building. An 1878 plat map of Rancho Valle de San José shows the building in ruins, indicating that the Carrillos had left and the building was abandoned by this date (Minto 1878) (Figure 10.12). Sometime after 1888, when the house was reoccupied and had become a family home for the Vail Ranch foreman, the remains of the original adobe block wall were torn out and replaced with the crude framing and exterior board and batten siding that presently exist, which was constructed with round nails. The adobe interior dividing walls and original interior board siding from the Carrillo period was left intact. This must have occurred in the 1890s or very early 1900s since photographs of the ranch house taken during the first decade of the 20th century show the exterior board and batten siding on the wall (Figures 10.13 and 10.14).

Two units were excavated in hopes of gaining insight into the structural evolution of the exterior east wall. The base of this wall is faced with a semi dressed, cement-mortared stone facing. Prior to the investigation, this facing appeared to be a foundation for the east wall. There are also two sets of masonry steps that provide access to the two doorways located on this side of the building (see Figure 10.3). Both the stone facing and steps were in place during the early 20th century and appear in circa 1910 photographs of the building (see Figures 10.13 and 10.14). The steps are built of cement-mortared cobbles coated with an exterior layer of cement.

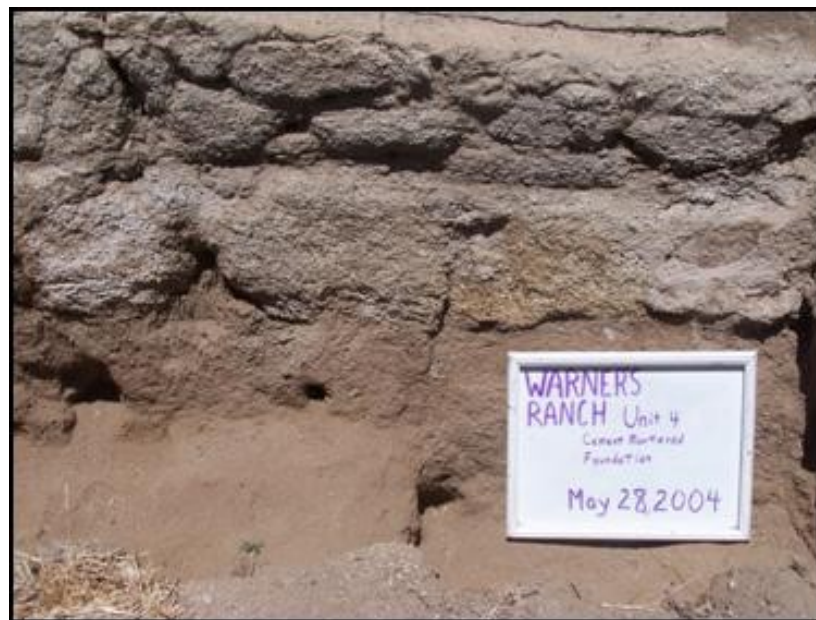
Figure 10.15. Cement mortared facing at the base of the Warner's Ranch House east wall in Unit 4. Courtesy Stephen R. Van Wormer and Susan D. Walter.

In order to see how the mortared facing tied into the steps, Unit 4 was placed adjacent to the south side of the front steps that are centered on the east side of the ranch house. Unit 5 was laid out beneath the division in the wall between the north and central wings to determine if the distinct building episodes of the central and north wing seen in the separation of the walls on the east facade were reflected in the supposed footing. Excavation resulted in the identification of a cement-mortared facing of semi-dressed granite fieldstones 16 to 18 inches thick that extended 8 to 10 inches below the present surface. The surrounding soil was the same moderately compacted tan to brown sandy loam soil that surrounded the entire building. Excavation of Unit 4 confirmed that the front steps were constructed in the same manner as the mortared facing but had been covered with a cement coating. In Unit 5, the facing did not reflect the separated building episodes indicated by the separation in the walls of the central and north wings since it covered the actual building foundation (Figures 10.15-10.18).

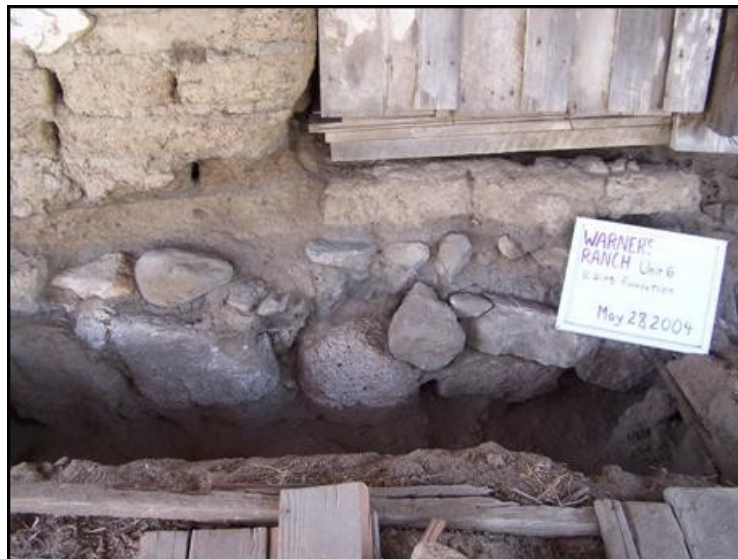
Figure 10.20. The stone foundation and the bottom course of the original adobe wall in Unit 6 underlying the northern wall wooden infill. Courtesy Stephen R. Van Wormer and Susan D. Walter.

The top course of the foundation was made of rounded stream cobbles approximately 5 to 8 inches long by 3 to 5 inches wide. These rocks were mortared in place with a dark brown mud. This same material was used to mortar existing adobe blocks on top of the foundation stones. A single course of these blocks continued across the base of the wooden infill. In the unit's east sidewall, the edge of the builder's trench that was dug for construction of the foundation was apparent. It was sealed by 4 to 5 inches of a tan hard packed soil in a semi uniform layer. This fill likely represents the original porch on this side of the building. It appears to have been put in as a layer of mud slurry. The current wooden porch was added in the late 19th or early 20th centuries (Figures 10.20-10.23).

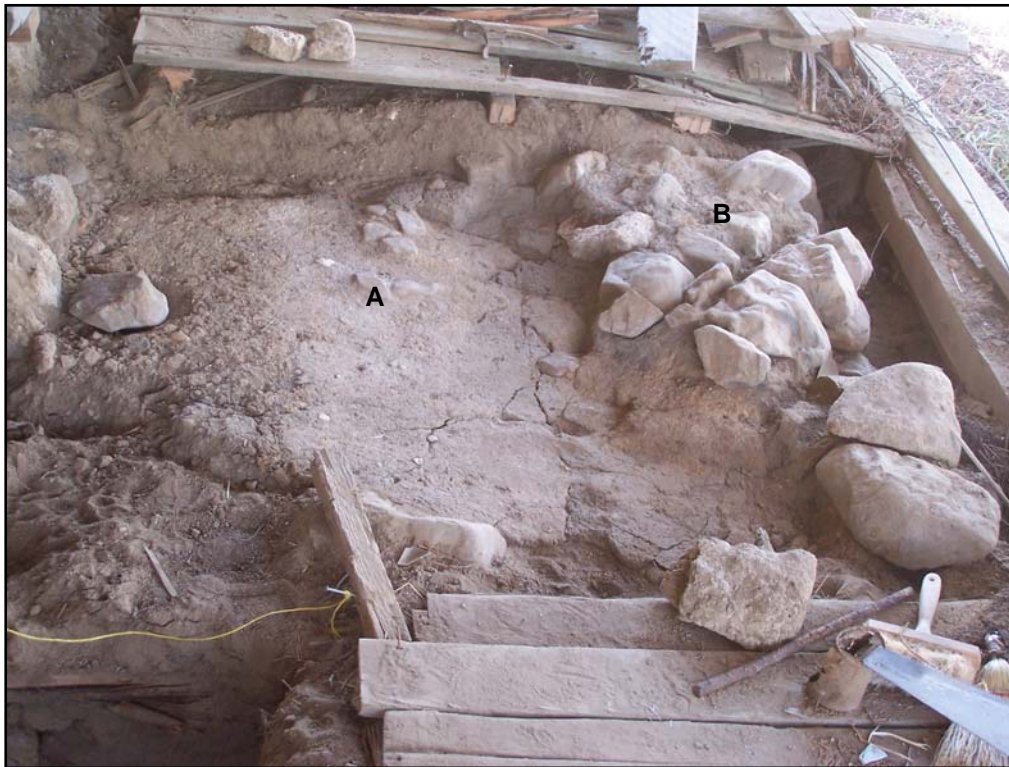
Figure 10.24. An area of the original porch cleared of debris. Note the hard packed earthen surface that appears to have been laid as a mud slurry (A) and the shallow cobble footing at along the north edge (B).
Courtesy Stephen R. Van Wormer and Susan D. Walter.

In order to examine further the construction of the original porch, an area measuring approximately 4 by 6 feet was cleared of debris to the west of the unit that exposed the dried slurry surface. The slurry layer of the original porch is about 6 feet wide and runs the entire length of the building along the north side. It is relatively level and supported by a cobble footing along its north side, which appears to have originally acted as a small facing wall along

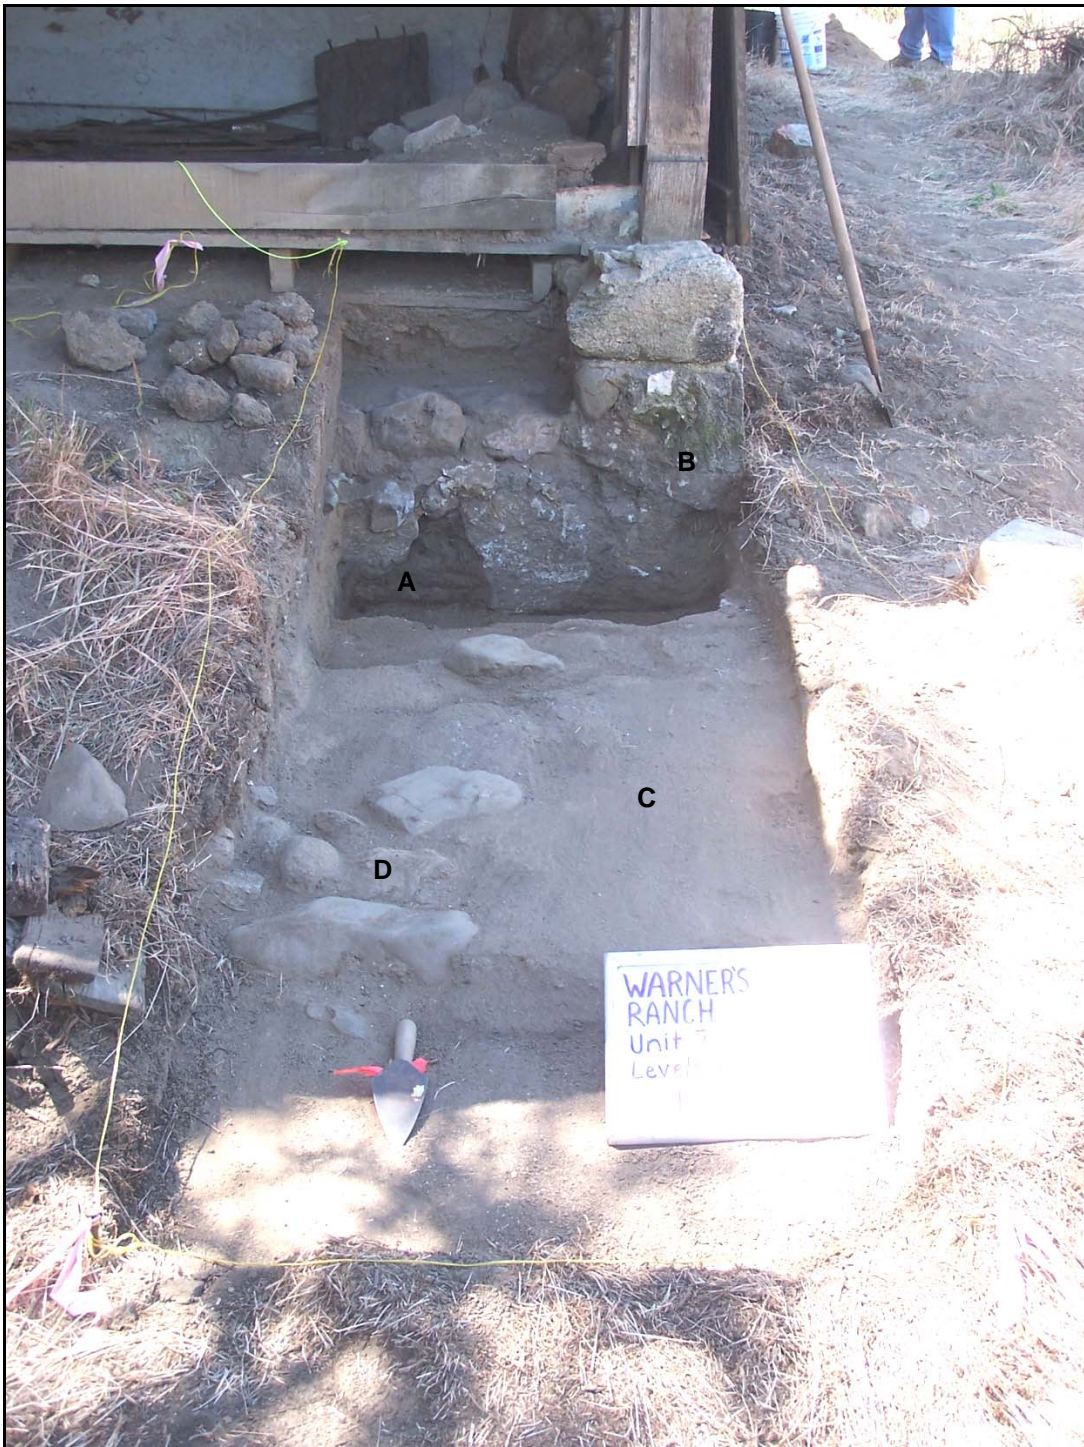
Figure 10.25. Unit 7, looking south. Note the stone foundation of the northern wall (A), the north end of the cement mortared stone facing along the east wall (B), the original surface of the packed mud porch (C), and the cobble footing along the north edge of the mud porch (D).
Courtesy Stephen R. Van Wormer and Susan D. Walter.

Since the original slurry porch was badly disturbed, the stratigraphic cross section revealed little information. Only a portion of the north end was partially intact. At this locus, the original slurry porch was about two inches thick. It was faced on the north side by two courses of rounded cobbles varying in size from approximately six to 12 inches in diameter. The northern edge of this facing was approximately 6 feet from the north wall of the building. The slurry rested on a leveled layer of moderately compacted brown sandy loam soil. It is likely that the porch was formed by constructing a small dry stacked cobble wall parallel to and approximately 6 feet from the north side of the building. The space between this wall and the building was filled within two to five inches from the top with soil to form a semi-level surface. The mud slurry was poured on top (Figures 10.25-10.27).

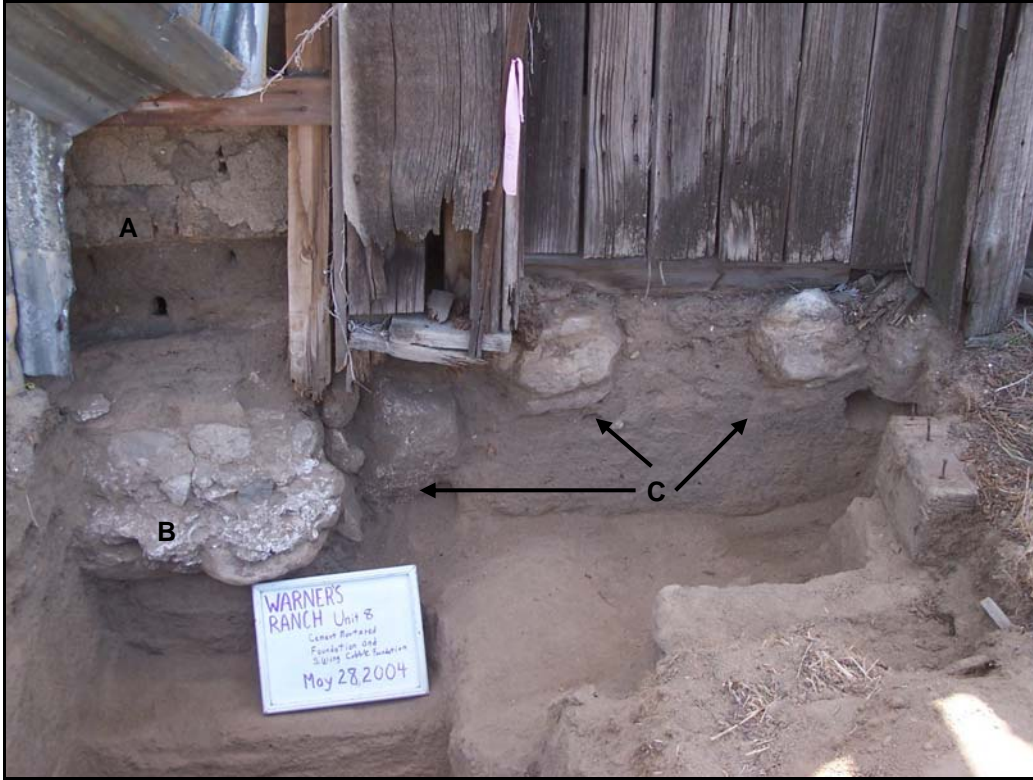
Figure 10.30. Unit 8, showing the adobe blocks of the western wall of the center wing (A), lime mortared cobble facing on the foundation of the center wing (B), and the remains of the cobble foundation for the original adobe wall on the west side of the south wing (C).
 Courtesy Stephen R. Van Wormer and Susan D. Walter.

along the east wall of the building. Here, however, much less care was taken; the work is much cruder. A refuse deposit was also encountered in the west end of the unit. The unit was expanded to the west and a sample taken from an area that measured approximately 3 feet by 3.5 feet by 3 feet deep (Figures 10.29 and 10.30).

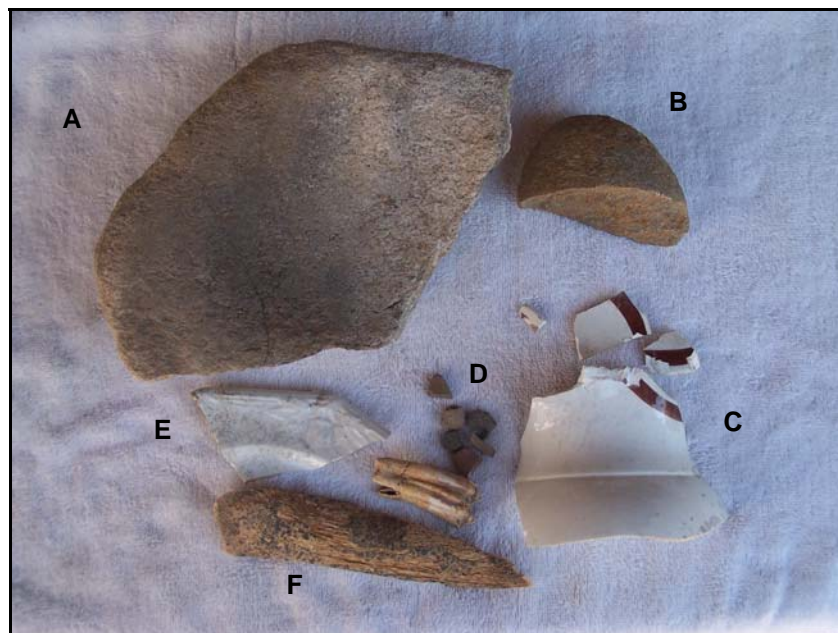
Figure 10.32. Artifacts from the refuse pit in Unit 8. (A) metate fragment, (B) mano fragment, (C) hand painted ewer, (D) Native American pottery sherds, (E), molded decorated plate, and (F) butchered beef bone fragments. The metate is approximately 10 inches across at its widest point. Courtesy Stephen R. Van Wormer and Susan D. Walter.

Artifacts included consumer, kitchen, garment and household items as well as building materials. Consumer items consisted of ale/porter bottles. Kitchen items included undecorated and molded earthenware cups, a saucer, a plate, and a bowl. In addition, various pieces of Native American pottery were found as well as a stone mano and a stone metate fragment. Over 300 grams of butchered beef bone were also recovered. Garment items included corset hardware and shell and metal buttons. Household remains consisted of a ceramic spittoon and a hand decorated earthenware ewer (Figure 10.32). Datable artifacts included an earthenware plate with the Fig pattern of J. Wedgwood and Company, which was registered in 1856 (Wetherbee 1985:87), and an undecorated earthenware saucer manufactured by G. Wooliscroft and Company between 1860 and 1863 (Godden 1999:359). A blown in mold black glass porter/ale bottle could only be dated as to having been made before 1920 but is typical of beverage containers that were common in the 1850s and 1860s. A crown cap recovered from level 2 dates after 1900 and is intrusive to the trash deposit and was probably carried to this depth by rodent activity.

The deposit appears to be a kitchen and household refuse pit dating from the 1860s when the Carrillo family occupied the ranch house. Carrillo kitchen refuse would likely include the Native American pottery as well as the mano and metate fragment. Native pottery was used by Hispanics living in Southern California for cooking pots and storage vessels throughout the 19th and into the early 20th century (Wade 2004). For this reason, and because it has occurred only in historical contexts, all Native American pottery recovered throughout the project has been considered to be from the historical period after the ranch house was built. The mano and metate are also items that would have been found in most Hispanic households. They were used for processing a variety of foods including corn to make tortilla masa, and to pound dried meat for machaca.

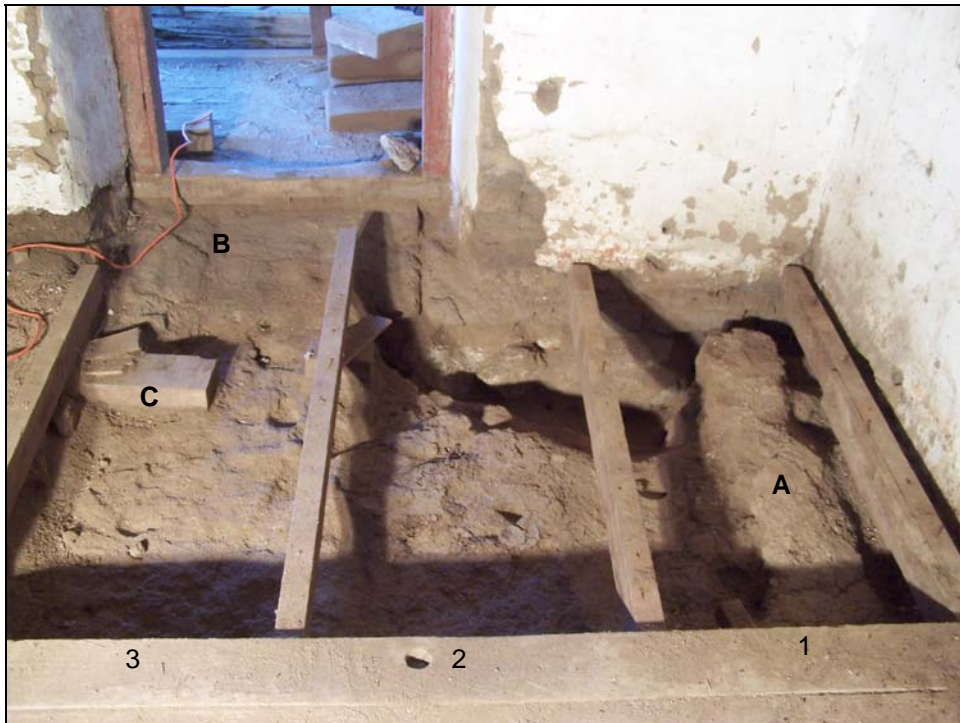
Figure 10.34. Sections 1, 2, and 3 of the Entry Room block excavation showing the earthen floors exposed after removal of the loose sandy loam fill. The upper floor has been worn away at this point due to traffic between the doorways. Only a small fragment remains on the west side (A). The blocks in the threshold of the doorway have been worn down to the level of the lower packed earth floor at (B). A wooden shim has been placed under the sleeper to level it (C). Courtesy Stephen R. Van Wormer and Susan D. Walter.

Under the loose soil fill remains of two hard flat earthen floors were encountered, consisting of packed clayey loam. In the east side of the room in Sections 5 and 6, the upper floor was intact and well preserved. However, on the east side of the room in Sections 1, 2, and 3, excessive past foot traffic between the doorway on the south wall of the entry room and the door on the room's west wall leading into the parlor had worn through the upper floor and exposed the extensively worn lower floor. The adobe blocks in the threshold of the southern doorway were also worn down to the second floor level (Figures 10.33-10.35).

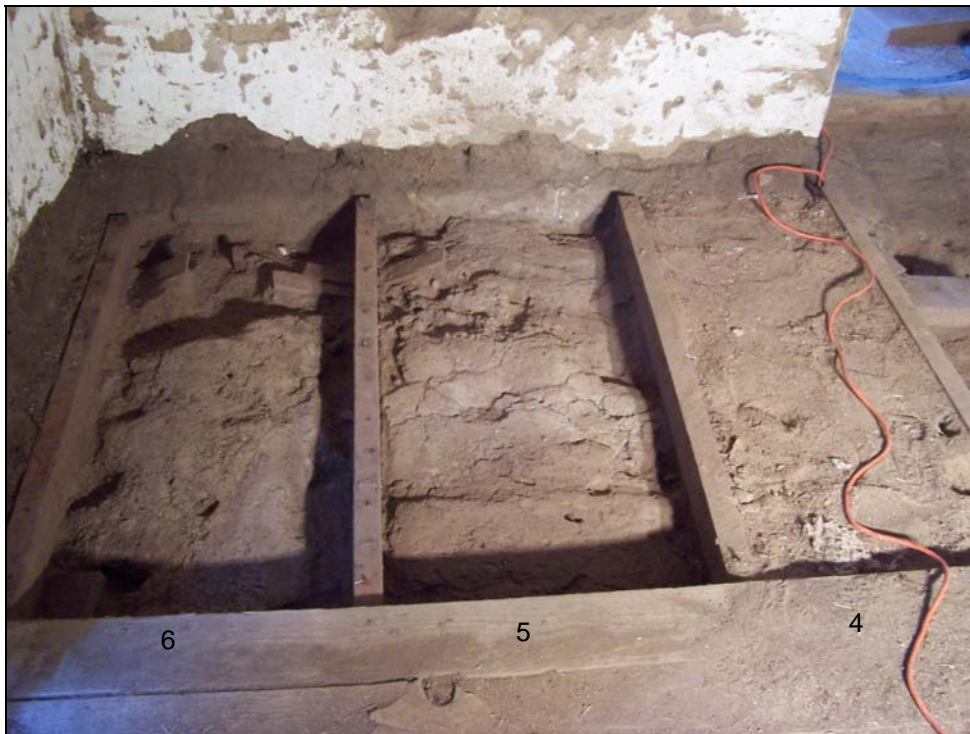
Figure 10.35. Sections 4, 5, and 6 of the Entry Room block excavation showing the upper packed earthen floor surface that was exposed after the loose fill between the sleepers was removed. The fill has not been taken out in Section 4. Courtesy Stephen R. Van Wormer and Susan D. Walter.

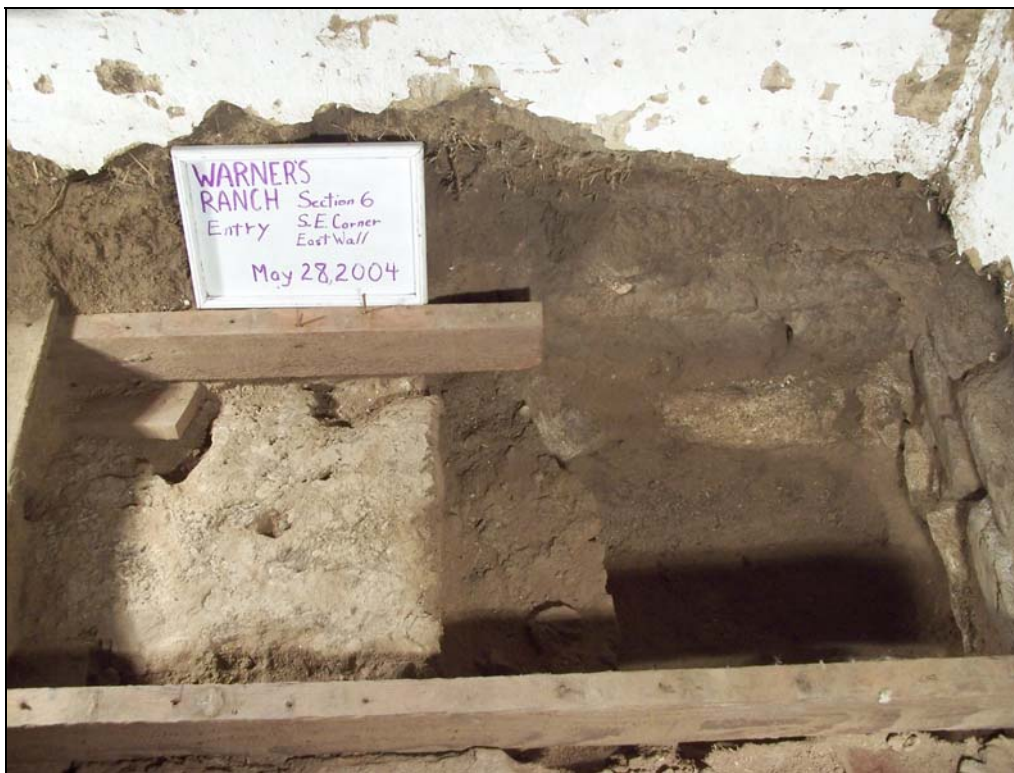
Figure 10.37. Entry Room Excavation Block Section 6 following excavation of the northeast corner, looking east. A portion of the far sleeper has been cut off to allow excavation access. Note (A) the present wooden floor board, (B) sleepers, (C) upper earthen floor, (D) lower earthen floor, (E) adobe blocks at the base of the wall, and (F) a single course of field stones underlying the wall.

dug out to fit the sleepers into the old packed earthen floor's surface. Loose dirt fill was then added between the sleepers to the level of the floorboards. As previously noted, the existing wooden floor was then nailed to the sleepers with machine cut square nails, suggesting a construction date prior to 1890 and certainly before 1910 (Figures 10.36 and 10.37).

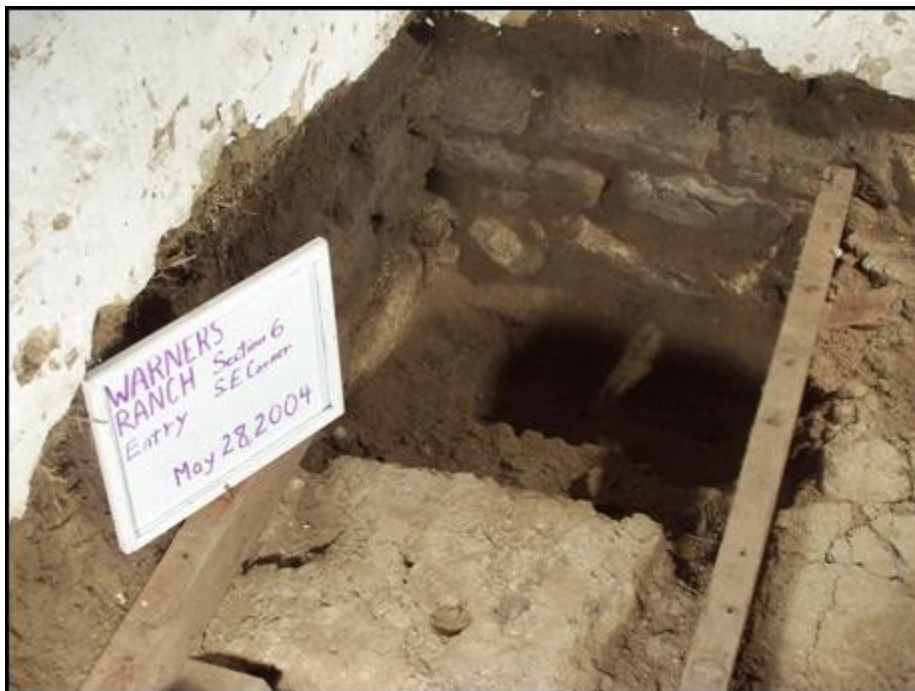
Figure 10.39. South side wall of excavated unit in Excavation Block Section 6. Note how the sleeper is resting in a shallow trench in the upper earthen floor. Courtesy Stephen R. Van Wormer and Susan D. Walter.

Foundations for the east, south, and west walls of this room consisted of a single course of irregular shaped granite fieldstones, varying in size from less than 6 inches to over 12 inches in diameter. They had been placed in the same moderately compacted brown sandy loam soil as the other foundations of the building. The foundation extended to a depth of approximately 8 to 10 inches below the bottom course of adobe block (Figures 10.38-10.43).

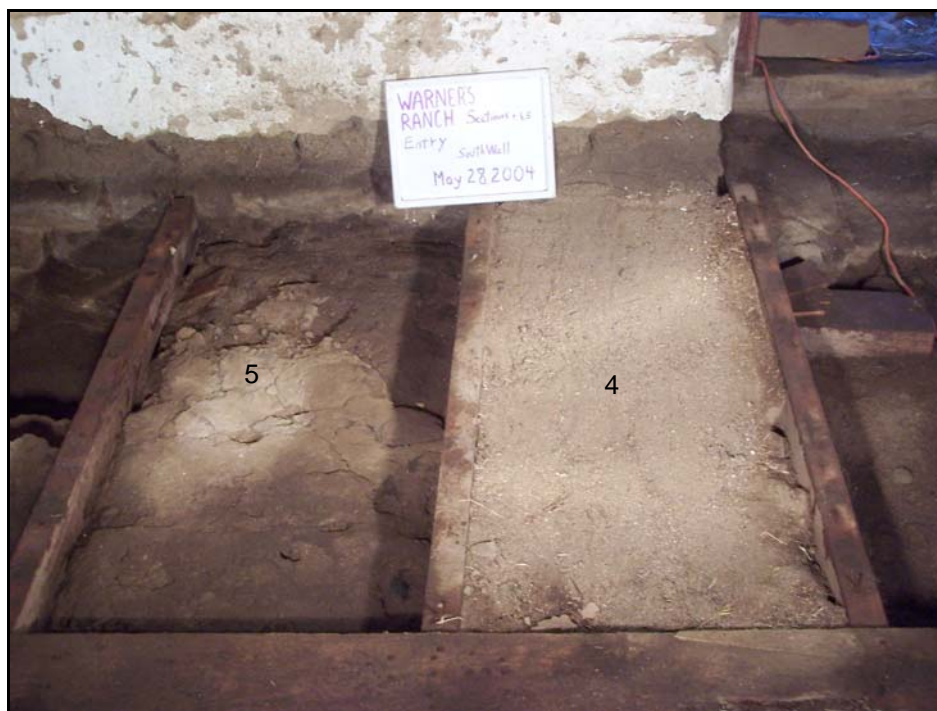
Figure 10.40. Block Excavation Sections 4 and 5. The upper earthen floor was left intact in Section 5 and the loose fill was left in place in Section 4. Courtesy Stephen R. Van Wormer and Susan D. Walter.

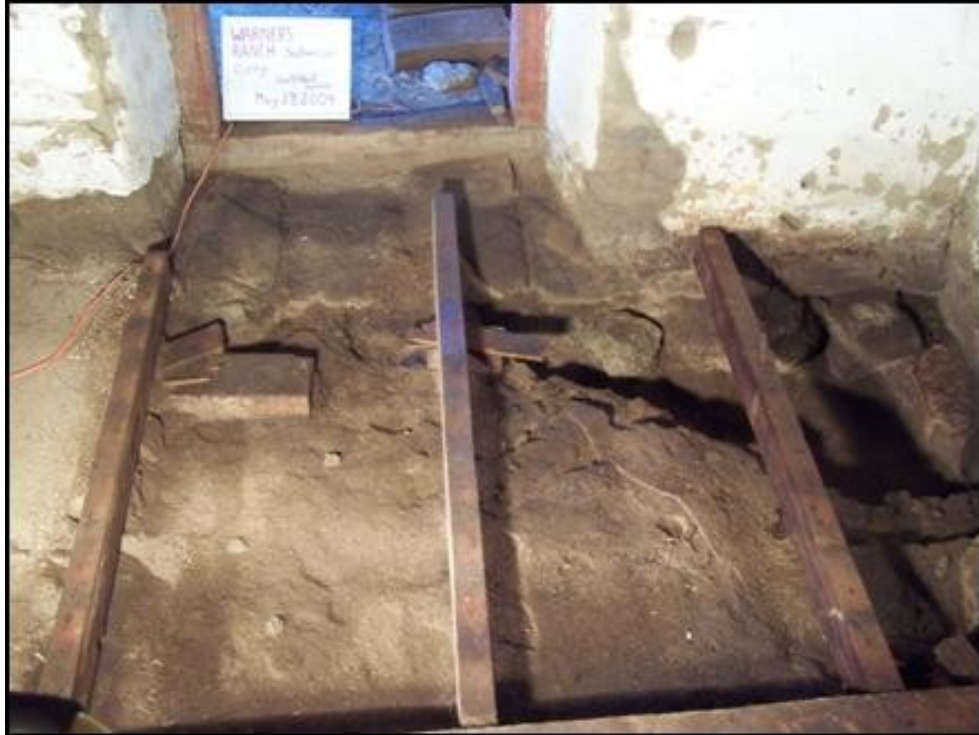
Figure 10.41. Block excavation Sections 2 and 3. The badly worn lower earthen floor and blocks in the door way can clearly be seen. Courtesy Stephen R. Van Wormer and Susan D. Walter.

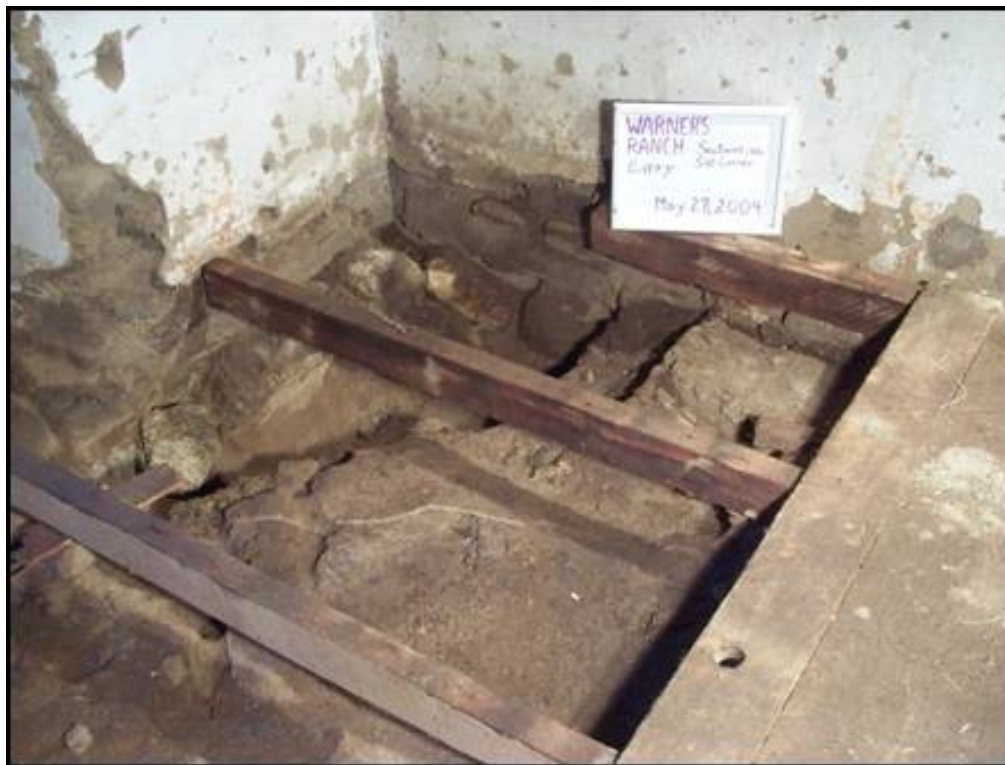
Figure 10.42. Overview of the excavation unit in the southwest corner of Excavation Block Section 6. Note the single course of large irregular shaped granite field stones in the foundation. Courtesy Stephen R. Van Wormer and Susan D. Walter.

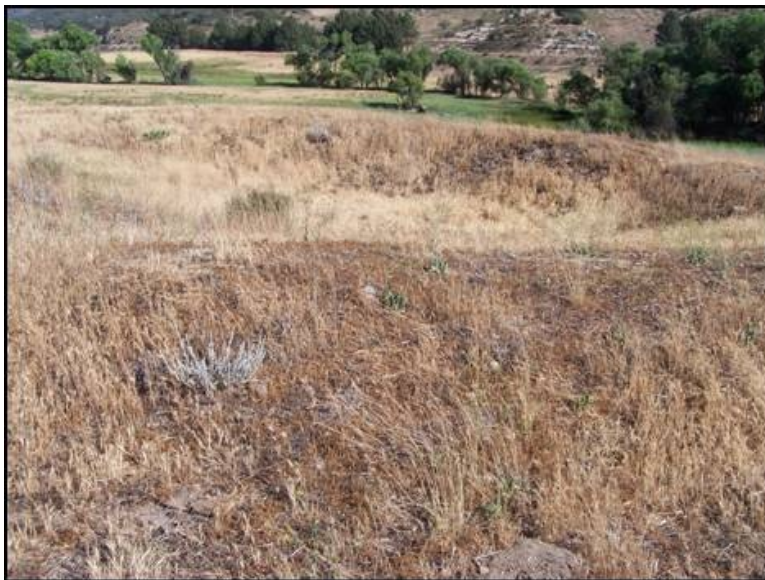
Figure 10.46. This small reservoir dating from the early 1900s has been excavated into the site where Reynolds' mapped the ruins of Warner's House in 1870. Courtesy Stephen R. Van Wormer and Susan D. Walter.

During this project, a survey was made of the knoll directly north of the ranch house on the north side of Buena Vista Creek, where Deputy Surveyor William Reynolds recorded ruins in 1870 that were identified by the Carrillos as the location of John Warner's trading post. The post had been burned by Indians in 1851 (Figures 10.44 and 10.45). A small reservoir, which cowboys currently working at the ranch believed was excavated by Sam Taylor in the early 1900s, is on the spot that Reynolds recorded as the location of Warner's house (Figure 10.46).

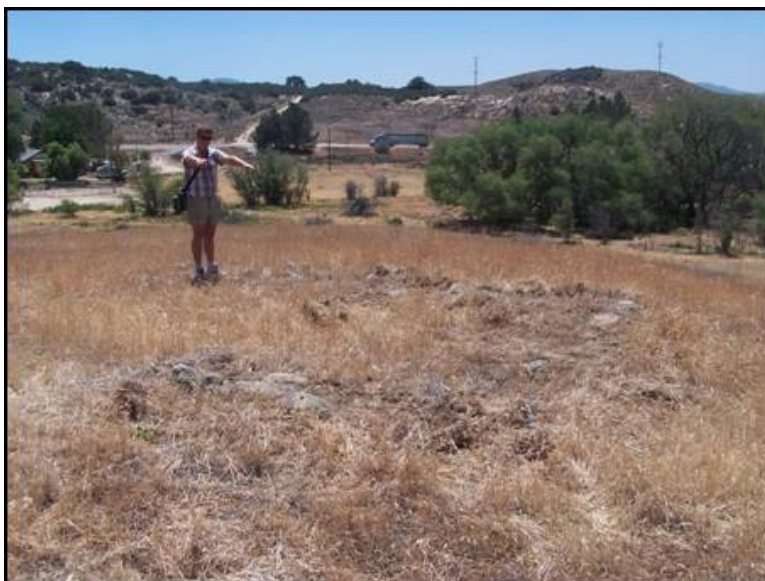
Figure 10.47. Historian Chris Wray points to the corners of a small rectangular cobble foundation near the location where Reynolds' mapped the ruins of Warner's blacksmith shop in 1870. Courtesy Stephen R. Van Wormer and Susan D. Walter.

Approximately 100 feet to the northwest on the edge of the knoll, a rectangular cobble foundation was encountered that measured approximately 15 by 20 feet and was open on the south end. This is near the spot that Reynolds recorded as the ruins of Warner's blacksmith shop (Figure 10.47). Between the reservoir and the cobble foundation, a scatter of artifacts was observed that had been brought to the surface in gopher mounds. Just to the east of the cobble foundation, there is a rectangular earthen mound, which may be the remains of a structure. To the east of this mound and to the north of the reservoirs are a series of rectangular depressions that may also be building remains (Figures 10.48 and 10.49). Time did not permit more accurate mapping and measuring of this site.

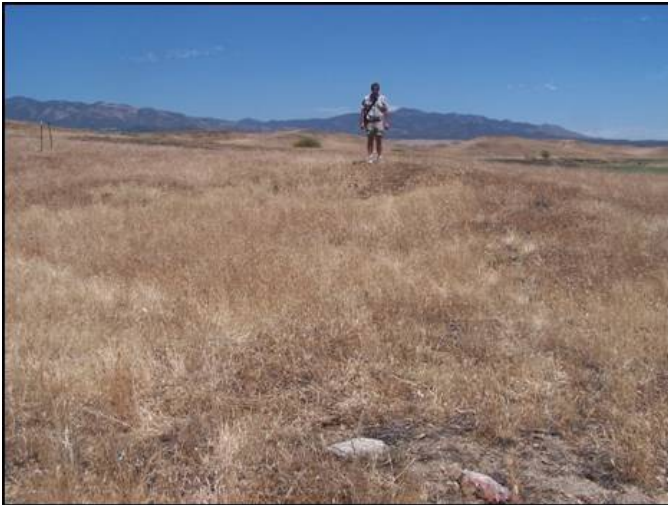
Figure 10.48. Chris Wray is standing on a rectangular earthen mound directly east of the cobble foundation shown in Figure 10.50. Courtesy Stephen R. Van Wormer and Susan D. Walter.

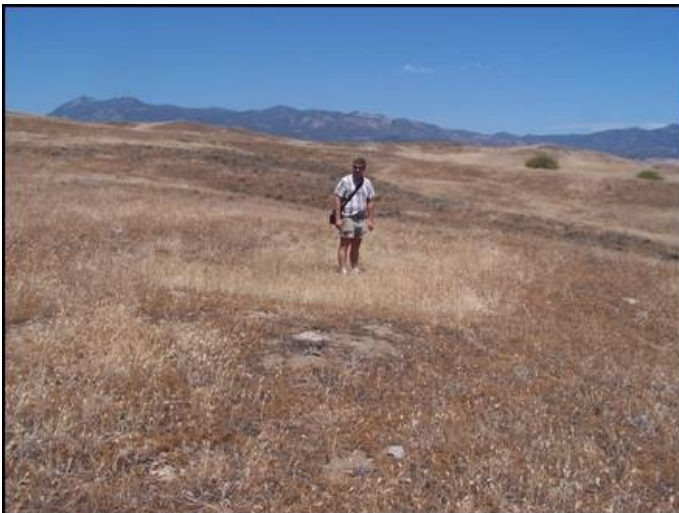
Figure 10.49. Chris Wray standing in one of several shallow rectangular depressions located approximately 100 feet east of the cobble foundation shown in Figure 10.50 and approximately 50 feet northeast of the reservoir shown in Figure 10.49. Courtesy Stephen R. Van Wormer and Susan D. Walter.

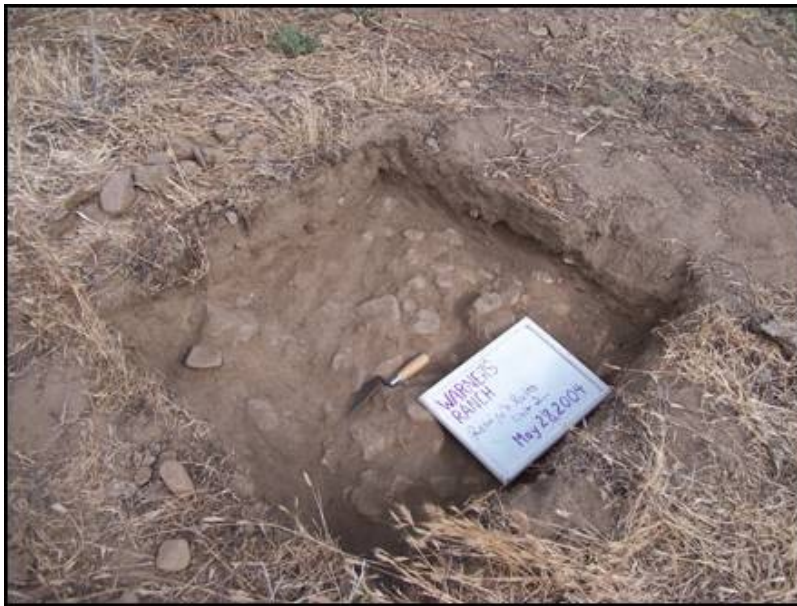
Figure 10.50. Unit 2 was excavated to obtain a sample from the artifact concentration at the Reynolds' Ruins site. Courtesy Stephen R. Van Wormer and Susan D. Walter.

at 12 inches below the surface on a layer of dense cobbles (Figure 10.50). Artifacts identified are listed in Appendix A, Table 8. The assemblage is dominated by kitchen items, although consumer, and livery items, as well as hardware and building materials were also recovered. Bottle glass fragments exhibited pontil marks and hand-applied lips, which date prior to 1885. Ceramics showed a wider range of dates. A bowl with the Sydenham, or one of the many imitations of the Sydenham pattern, was identified. This pattern was registered in 1853 (Wetherbee 1985:49-59). A cup decorated in the Colombia pattern dated after 1855 (Wetherbee 1985:56-57), and a flow mulberry plate exhibiting the Pelew pattern was manufactured after 1840 (Williams 1981:45; 1986:177) (Figure 10.51). The ceramic dates of 1853 and 1855 are too late to be associated with Warner's trading post, which burned in the fall of 1851. This preliminary examination would suggest that the refuse on this site is associated with the Carrillo period of occupation.

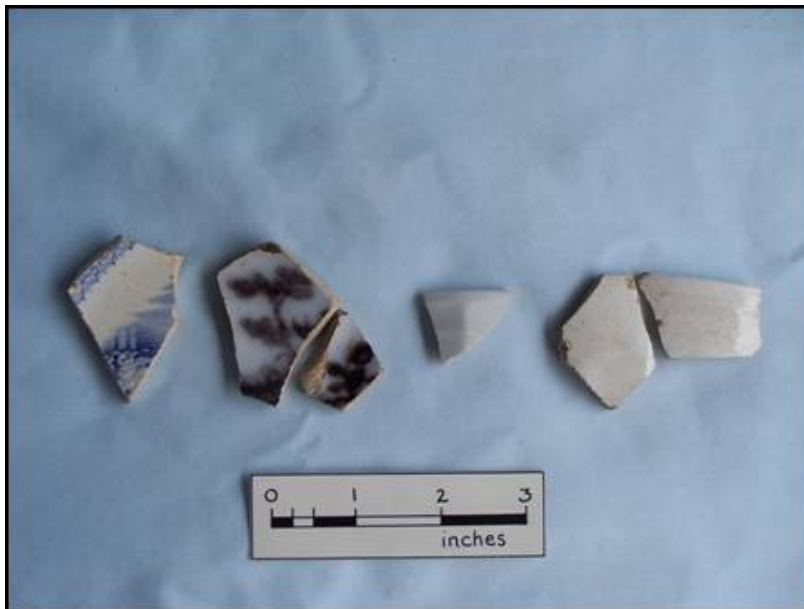
Figure 10.51. Ceramic sherds from the Reynolds' Ruins site. From left to right: unidentified transfer blue plate, flow mulberry Pelew pattern plate manufactured after 1840, Columbia pattern molded earthenware cup manufactured after 1855, and molded earthenware Sydenham pattern bowl manufactured after 1853. Courtesy Stephen R. Van Wormer and Susan D. Walter.
